FIBERGLASS BOATBUILDING: Hull-Deck Joints

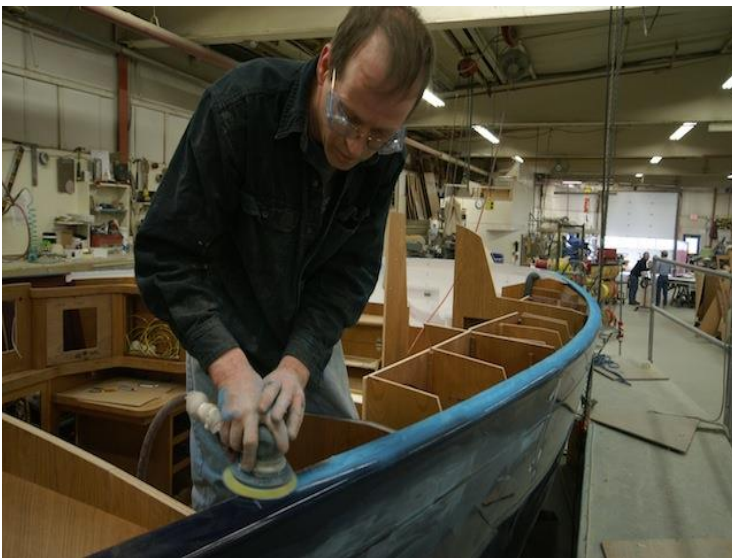
The bond between a deck and hull is critical. Ideally, it should include all interior bulkheads and partitions. The best practice is to tab these separately to both the deck and hull so that the finished boat is a solid unitary structure. Often, however, these important vertical structures are merely tacked to the deck (or worse, to a deck liner) with adhesive putty. In all cases, the exterior perimeter of the hull and deck must be directly joined to each other. This primary hull-deck joint is often the area most likely to leak when you are actually using a boat. Normally you only learn about such leaks sailing closehauled into a fresh breeze with the boat well heeled.

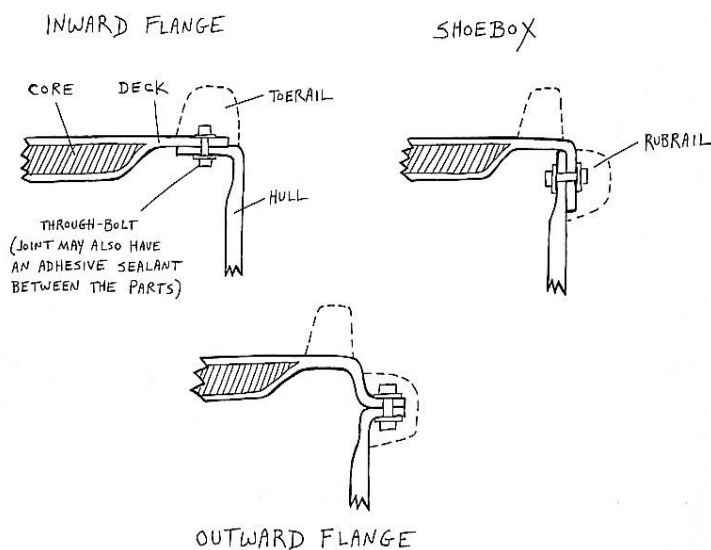
There are many different ways to engineer a hull-deck joint, particularly if you consider the myriad methods for installing caprails, toe rails, and rubrails on top of them. Their basic architecture, however, falls into three categories. The most common method on sailboats is an inward horizontal hull flange mated to an outward-facing flange or margin on the deck. Another option is the so-called shoebox joint, where a downward-facing vertical deck flange fits like a shoebox lid over a vertical lip on the hull. In the third variant both the deck and hull have outward-facing horizontal flanges that are joined together.

However a hull-deck joint is formed, what's most important is how the two surfaces are joined together. Most high-quality joints these days are bedded with a tenacious adhesive sealant (3M's 5200 compound is often used, for example) and are through-bolted at regular short intervals (1/4-inch bolts on 6- or 8-inch centers are highly recommended). An acceptable alternative is to glass over a bedded joint with fiberglass tape so that the hull and deck effectively become one part. The most bulletproof method is do all three: bed the joint, through-bolt it, then glass it over.

Otherwise the difference in terms of quality between the basic types of joints is open to debate. Some prefer the double outward-facing flange because the joint is outside of the boat. It is much easier to install through-bolts on a joint like this; it's also easy to assure a good fit and trim away excess material. Others dislike these joints because they are more likely to be damaged in collisions. The flip side of this argument is that repairs can also be made more easily. The other types of joints, by comparison, are better protected but are also harder to install and repair, as the working surfaces are hard to access. Probably the most problematic type is the shoebox joint, as the tolerances between the hull and deck are quite fine and a close fit is hard to achieve.
